DEPARTMENT OF TRANSPORTATION**DIVISION OF ENGINEERING SERVICES**

Contract #: 04-0120F4Cty: SF/ALA Rte: 80 PM: 13.2/13.9File #: 69.28**WELDING INSPECTION REPORT****Resident Engineer:**Siegenthaler, Peter**Address:** 333 Burma Road**City:** Oakland, CA 94607**Report No:** WIR-023001**Date Inspected:** 25-Apr-2011**Project Name:** SAS Superstructure**OSM Arrival Time:** 700**Prime Contractor:** American Bridge/Fluor Enterprises, a JV**OSM Departure Time:** 1900**Contractor:** Zhenhua Port Machinery Company, Ltd (ZPMC), Changxing Island **Location:** Shanghai, China**CWI Name:** Zhu Zhong Hai**CWI Present:** Yes No**Inspected CWI report:** Yes No N/A**Rod Oven in Use:** Yes No N/A**Electrode to specification:** Yes No N/A**Weld Procedures Followed:** Yes No N/A**Qualified Welders:** Yes No N/A**Verified Joint Fit-up:** Yes No N/A**Approved Drawings:** Yes No N/A**Approved WPS:** Yes No N/A**Delayed / Cancelled:** Yes No N/A**Bridge No:** 34-0006**Component:** OBG Segments**Summary of Items Observed:**

OBG Trial Assembly Yard

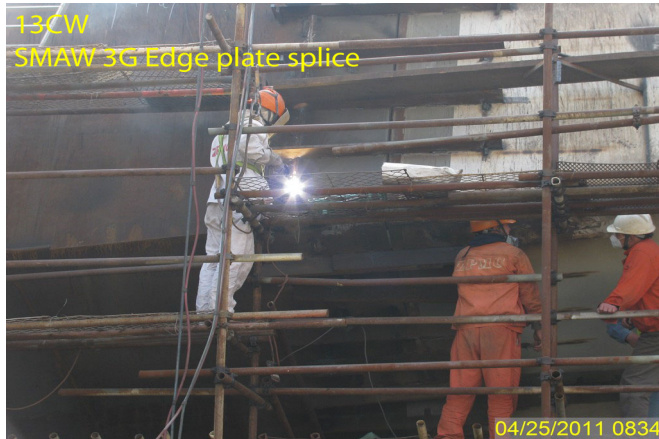
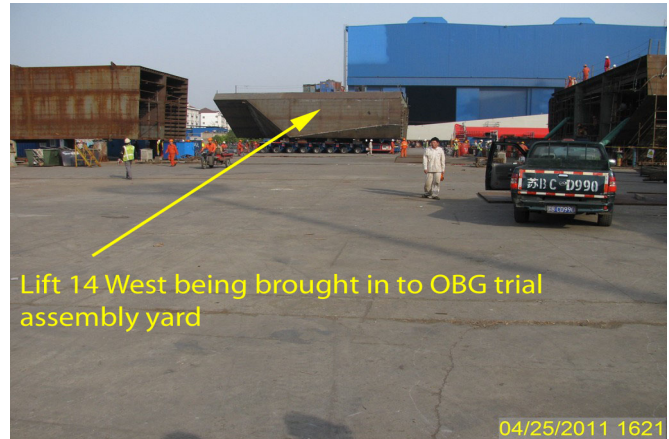
Unless otherwise noted, all work observed on this date appeared to generally comply with applicable contract documents.
